Gallatin Public Utilities Water • Sewer • Natural Gas

Re: Agreed Order - Case No. WPC11-0066

Item No. 9 - Submittal of Annual Report

Sanitary Sewer Overflow Response Plan (SSORP):

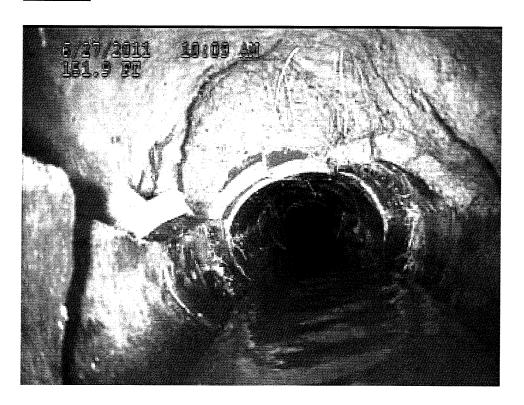
BEFORE

EAST BROADWAY SEWER MAIN REPLACEMENT (PIPE BURSTING)

To date this project has – replaced approximately 36,370 linear feet of gravity sewer main with HDPE pipe, replaced 288 sanitary sewer services, rehabilitated and epoxy line 1,150 vertical feet of manholes. A series of before/after photographs are attached to this report as examples of the issues corrected and work performed during this project.

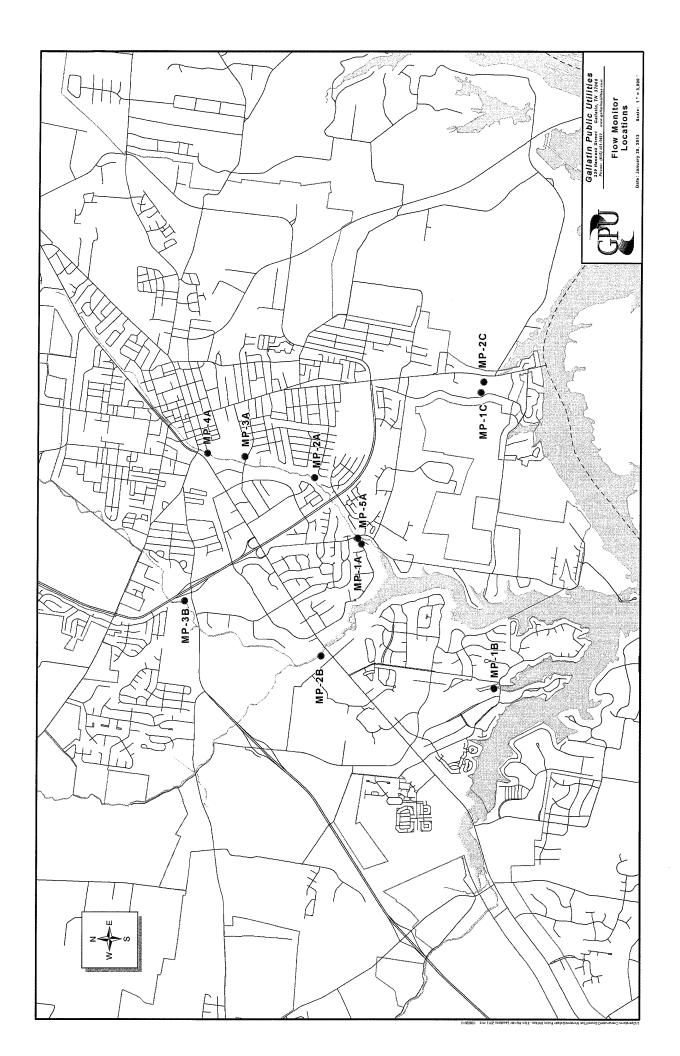
We continue to monitor and evaluate sanitary sewer system flows utilizing a network of 13 permanent flow monitors. This network of flow monitors, strategically located throughout our sanitary sewer collection system (see attached map), provides us with the ability to monitor flows in our collection system on a "near" real time basis; while also providing a monthly report of the wastewater flows in the collection system. This information is utilized to identify areas of the sanitary sewer collection system with flow volumes that warrant additional inspection and evaluation. The data is also utilized to evaluate the effectiveness of our on-going sanitary sewer system modernization and rehabilitation efforts.
